THE INVESTIGATION OF PHYSICAL AND MECHANICAL PROPERTIES OF MORTARS USED IN HISTORICAL BUILDINGS IN HARRAN (SANLIURFA, TURKEY)

In this study, a physical and mechanical property of mortar used in historical buildings in the region in Harran is investigated. The mortar samples were taken in accordance with the standards from Şanlıurfa Castle, Harran Mound, Harran University, Harran City Walls, Harran Castle and Harran Grand Mosque which are located in the Harran region. Mass and volume of water absorption rates, mass per unit volume, specific gravity and porosity had been found in order to specify the physical properties of mortar samples. In addition, grading of aggregates which is forming mortar is calculated. To specify the mechanical properties of mortar specimens also compressive strength had been found by 40x40x40 mm cube-shaped cut. The values that found in the tests carried out on mortar specimens was similar to results reported in the literature. It was observed that components of mortar samples were made according to a specific design. The values that found in the results of physical and mechanical analysis are very close to the specified value in TSE (Turkish Standard). Th

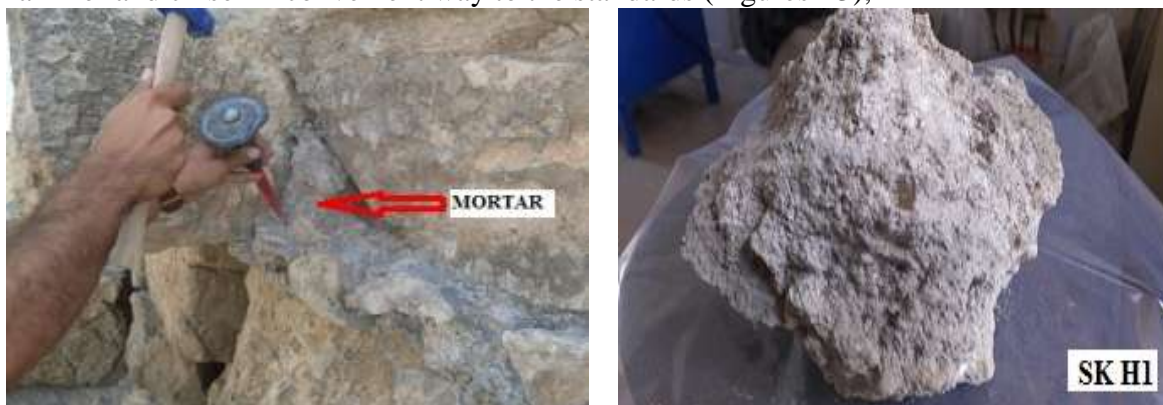
Figure 1. Mortar sample numbered SK H1 which was taken from Şanlıurfa Castle

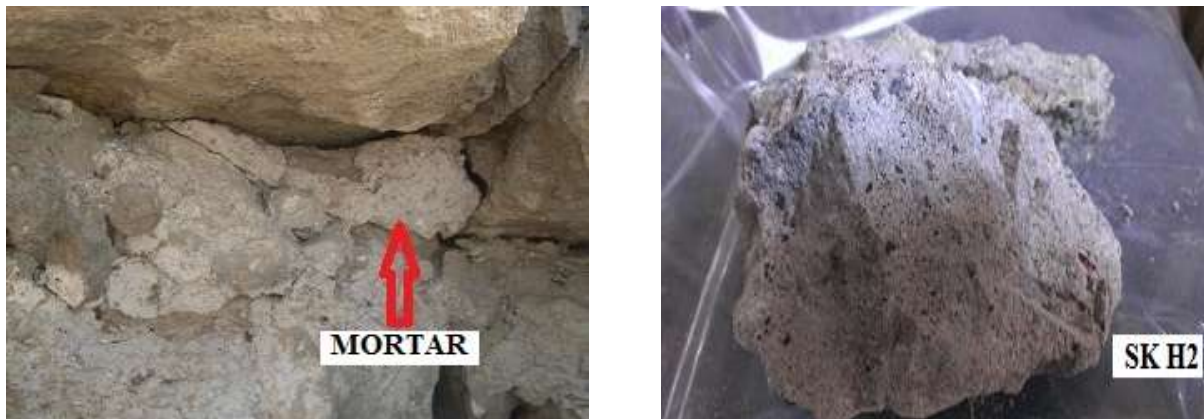
Figure 2. Mortar sample numbered SK H2 which was taken from Şanlıurfa Castle

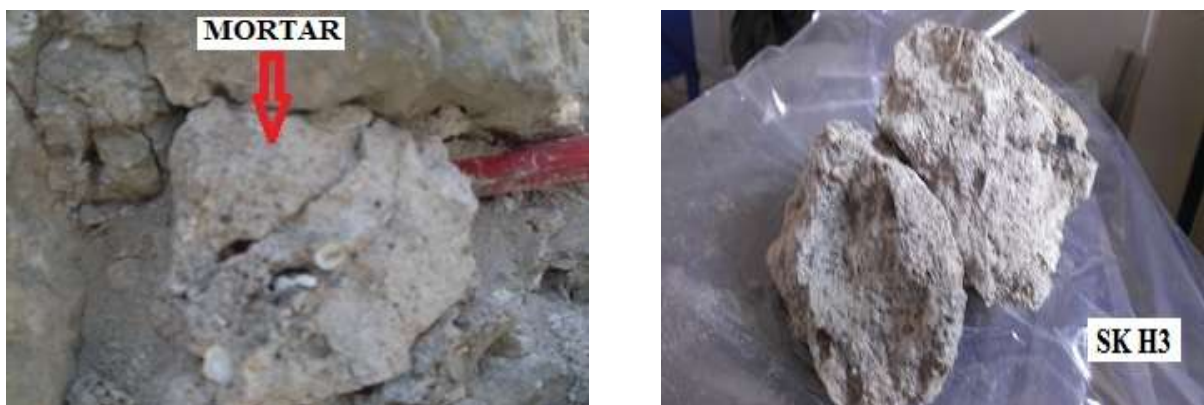
Figure 3. Mortar sample numbered SK H3 which was taken from Şanlıurfa Castle

As a result of investigations conducted in Şanlıurfa Castle three points which are eligible to receive the mortar samples was determined. The most important factor for determining the point for eligible mortar sample, it has been noted the original structure of the mortar not to be intact. Received mortar samples are masonry mortar. Mortar samples was taken by help of hammer and chisel in convenient way to the standards (Figures1-3),

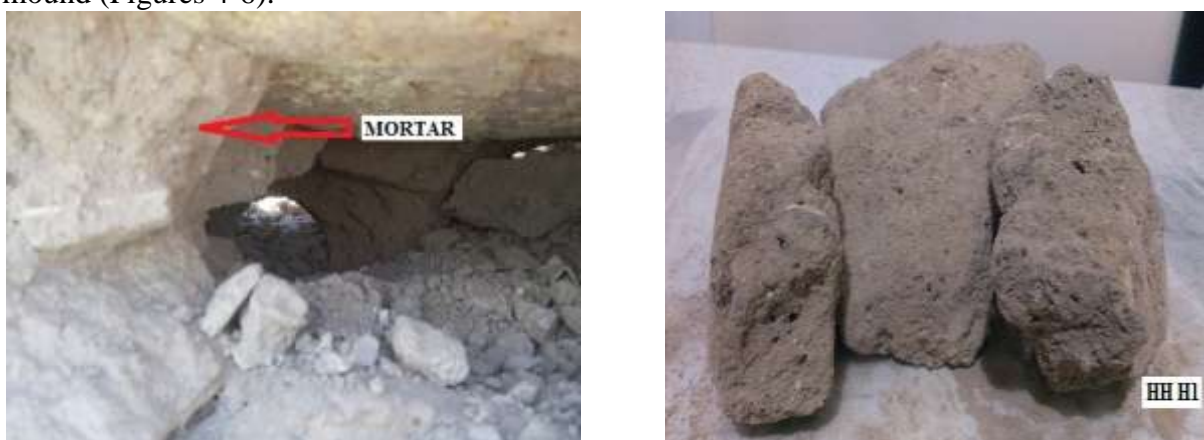
Figure 4. Mortar sample numbered HH H1 which was taken from Harran Mound

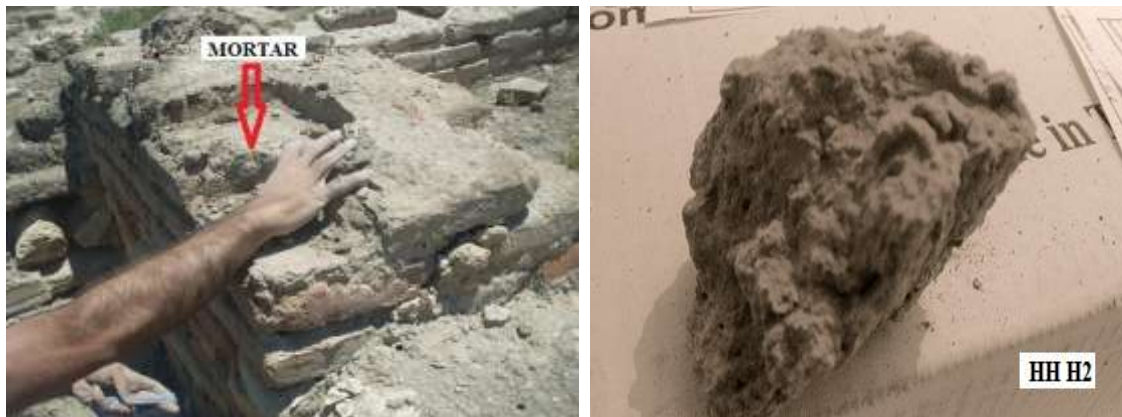
Figure 5. Mortar sample numbered HH H2 which was taken from Harran Mound

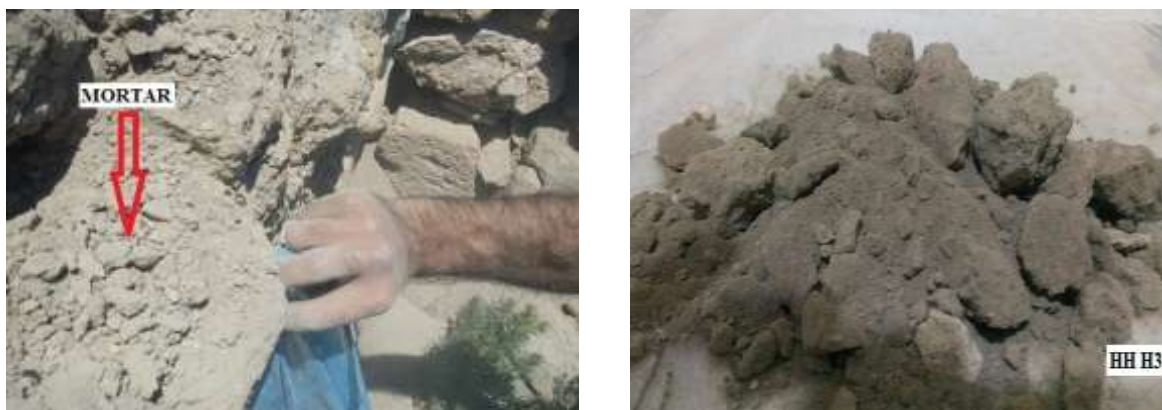
Figure 6. Mortar sample numbered HH H3 which was taken from Harran Mound

The binding material of The Harran Mound was mud mortar. As a result of investigations conducted three points which are eligible to receive the mortar samples was determined. The most important factor for determining the point for eligible mortar sample, it has been noted the original structure of the mortar not to be intact. Mortar samples were taken in convenient way to standards from the masonry mortar of the rooms located in the northwest of the mound (Figures 4-6).

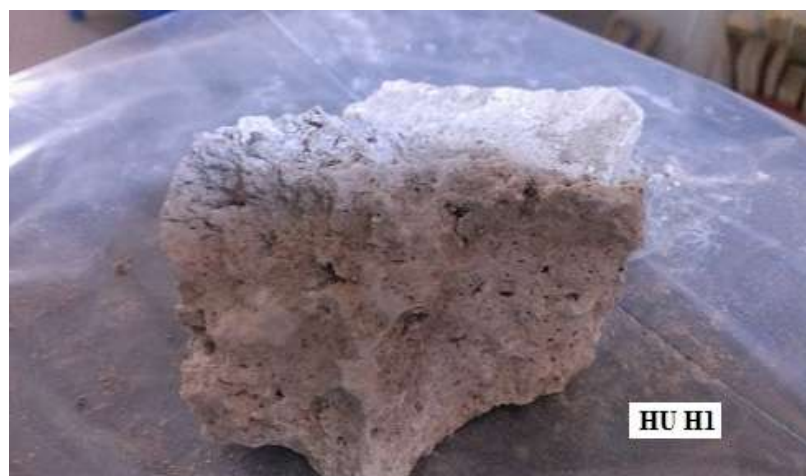
Figure 7. Mortar sample numbered HU H1 which was taken from Harran University

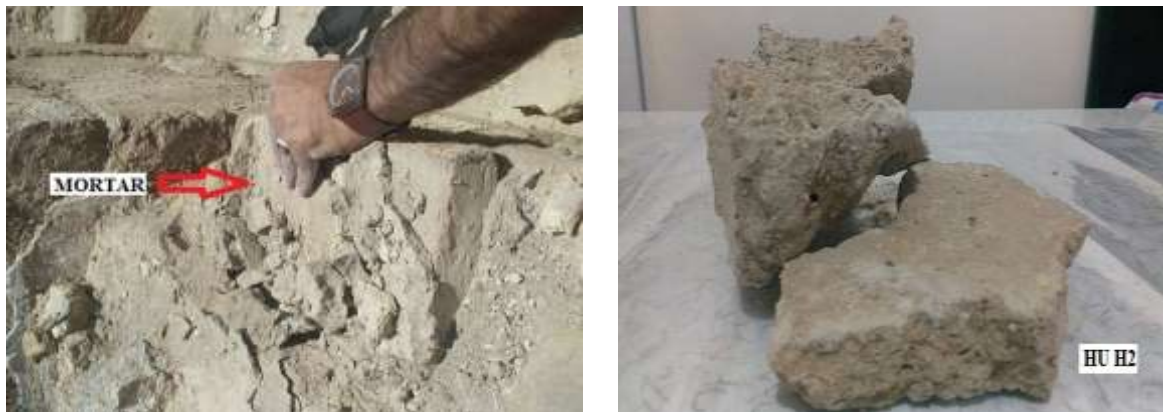
Figure 8. Mortar sample numbered HU H2 which was taken from Harran University

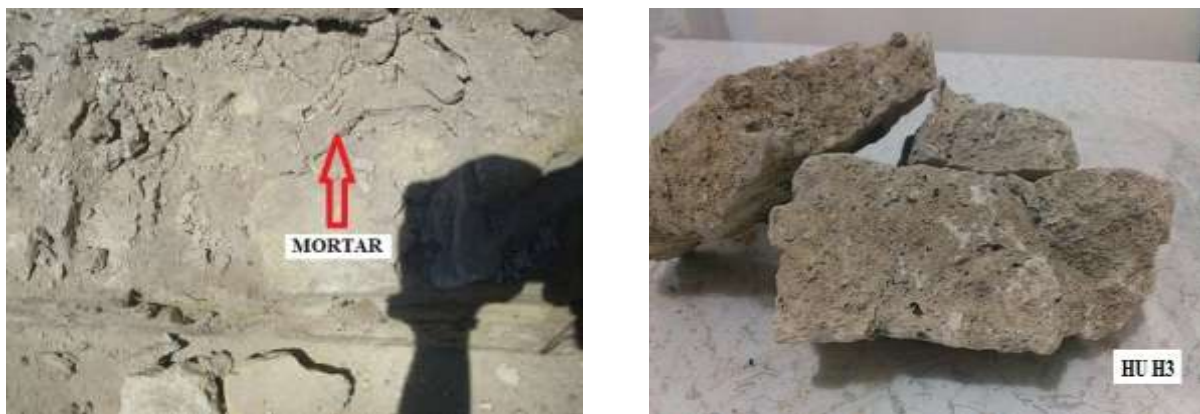
Figure 9. Mortar sample numbered HU H3 which was taken from Harran University

Harran University is located in the north east of Harran Grand Mosque as location. When we examine the current status of Harran University structure parts which surviving until today; 1- 1.5 meters in height walls of rooms which are forming the Harran University. Eligible to receive mortar sample points were specified on masonry mortar of these walls. To get the original mortar samples removing one or two stone of these walls, mortar samples was taken in convenient way to standards. (Figures 7-9),

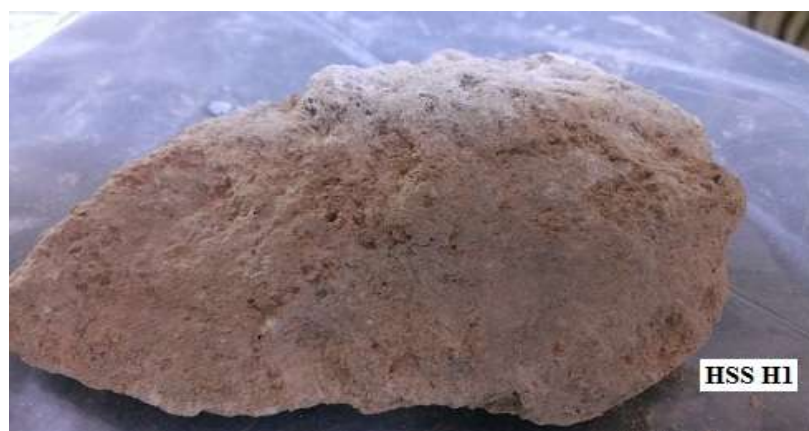
Figure 10. Mortar sample numbered HSS H1 which was taken from Harran City Walls

After examining the current status of Harran City Walls three points which are eligible for mortar specimens were determined. The determined points are on mesh mortar of the rear wall of Aleppo door which is extant. Mortar samples were taken in convenient way to the standards from this masonry mortar. (Figures 10-12).

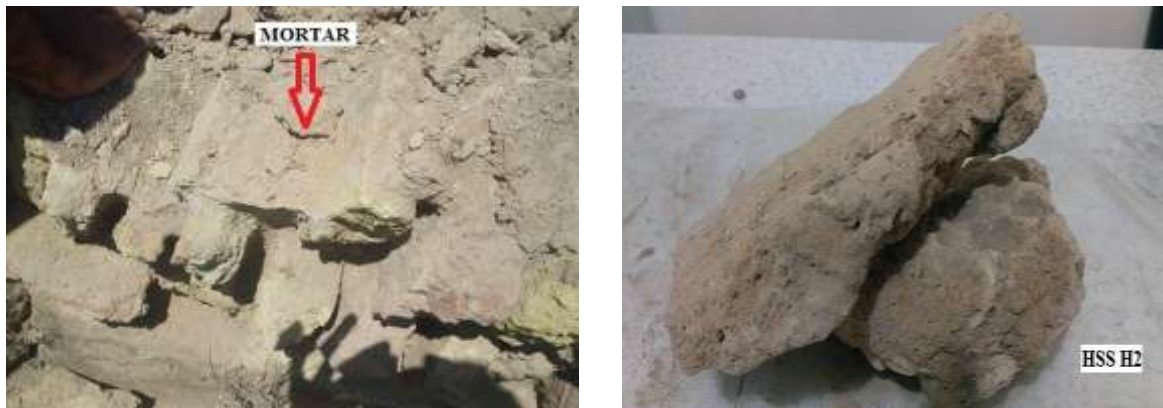
Figure 11. Mortar sample numbered HSS H2 which was taken from Harran City Walls

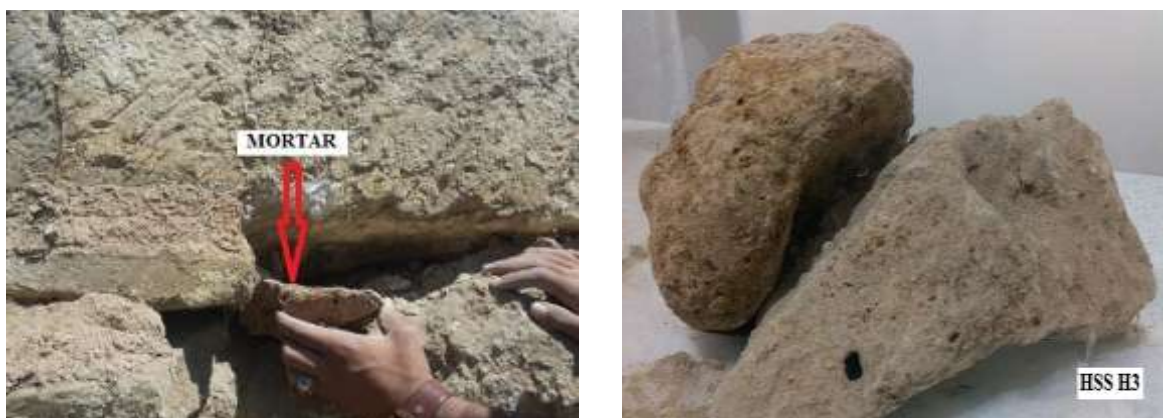
Figure 12. Mortar sample numbered HSS H3 which was taken from Harran City Walls

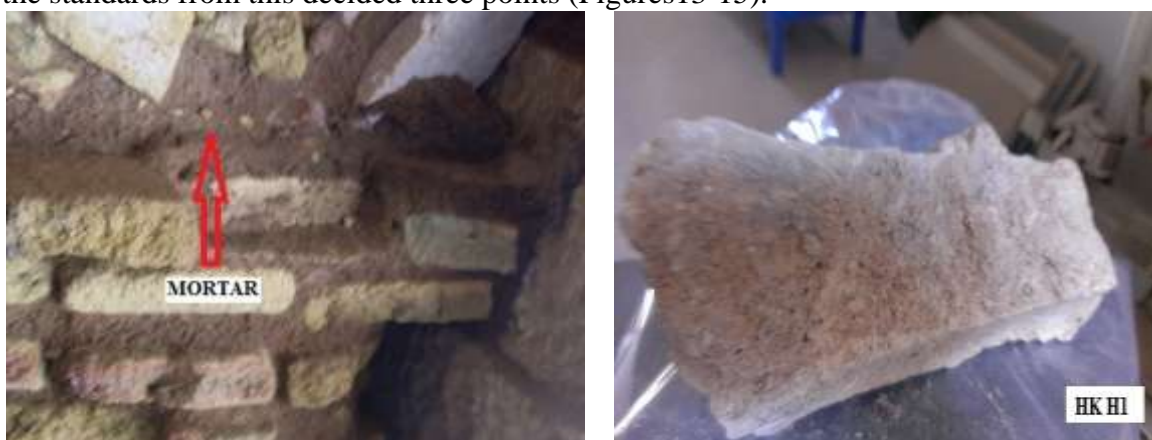
Figure 13. Mortar sample numbered HK H1 which was taken from Harran Castle

After examining the current state of the building three different points which are eligible for mortar specimens were identified. The first of these specified points: was masonry mortar of bottom wall of the north-west corner of the castle, the second point: was masonry mortar of the bricks forming the arch at the top of the castle and the third point was plaster mortar of top wall of the eastern facade of the castle. Mortar samples was taken in convenient way to the standards from this decided three points (Figures13-15).

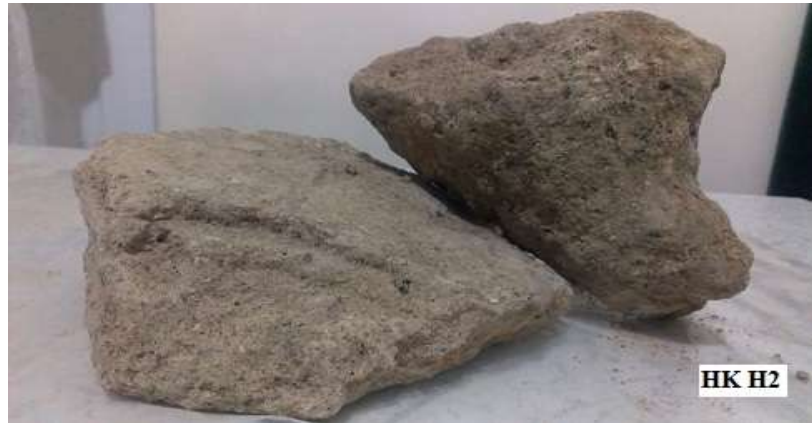
Figure 14. Mortar sample numbered HK H2 which was taken from Harran Castle

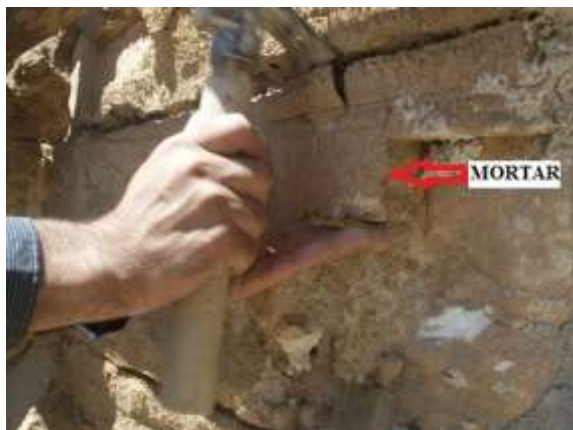
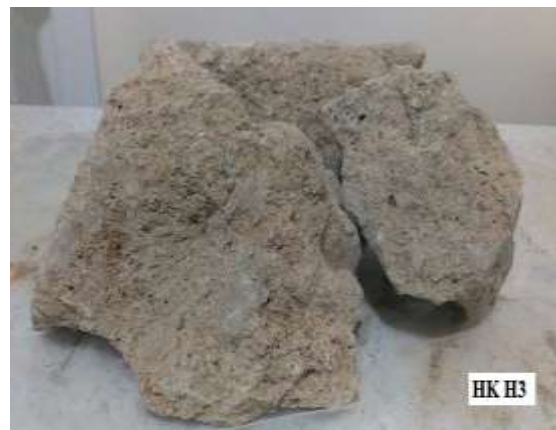
Figure 15. Mortar sample numbered HK H3 which was taken from Harran Castle

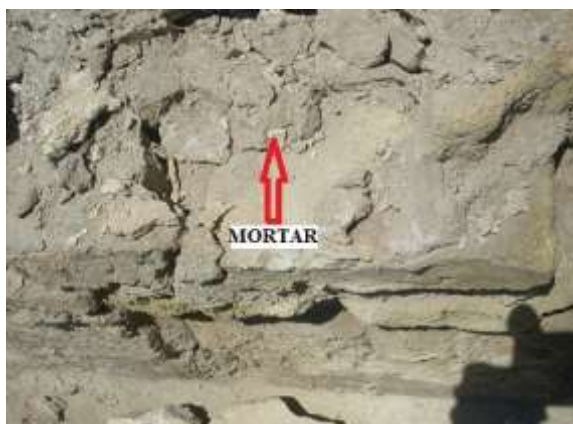
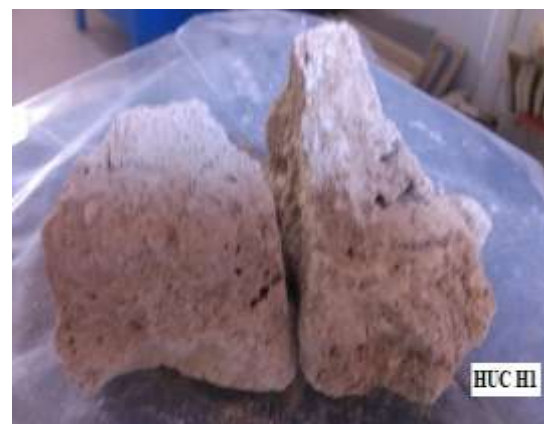
Figure 16. Mortar sample numbered HUC H1 which was taken from Harran City Walls

Harran Grand Mosque, is located at the north of the Harran Mound. After examining the current state of the building three different points which are eligible for mortar specimens were identified. These points were on the bottom of the wall on the eastern front. Mortar samples were taken in convenient way to the standards from these decided three points. (Figures 16-18.).

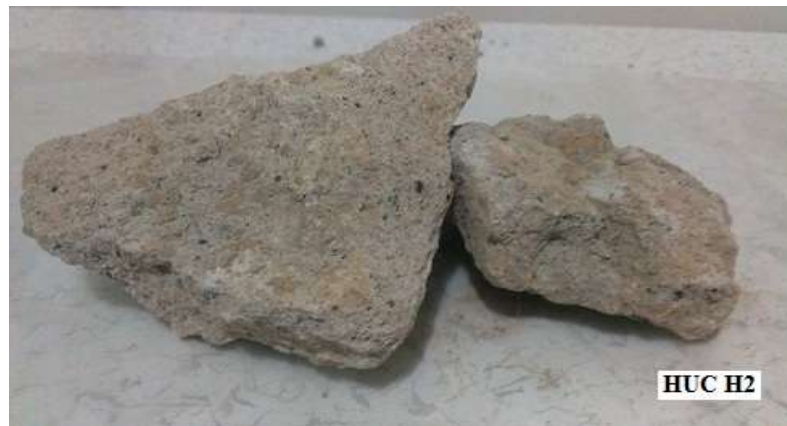
Figure 17. Mortar sample numbered HUC H2 which was taken from Harran City Walls
